NSWC TR 06-390

# **SAFETY EVALUATION OF THE EXPENDABLE SOUND VELOCITY PROBE (SSXSV)**

AUGUST 1986

**NAVAL SURFACE WEAPONS CENTER**

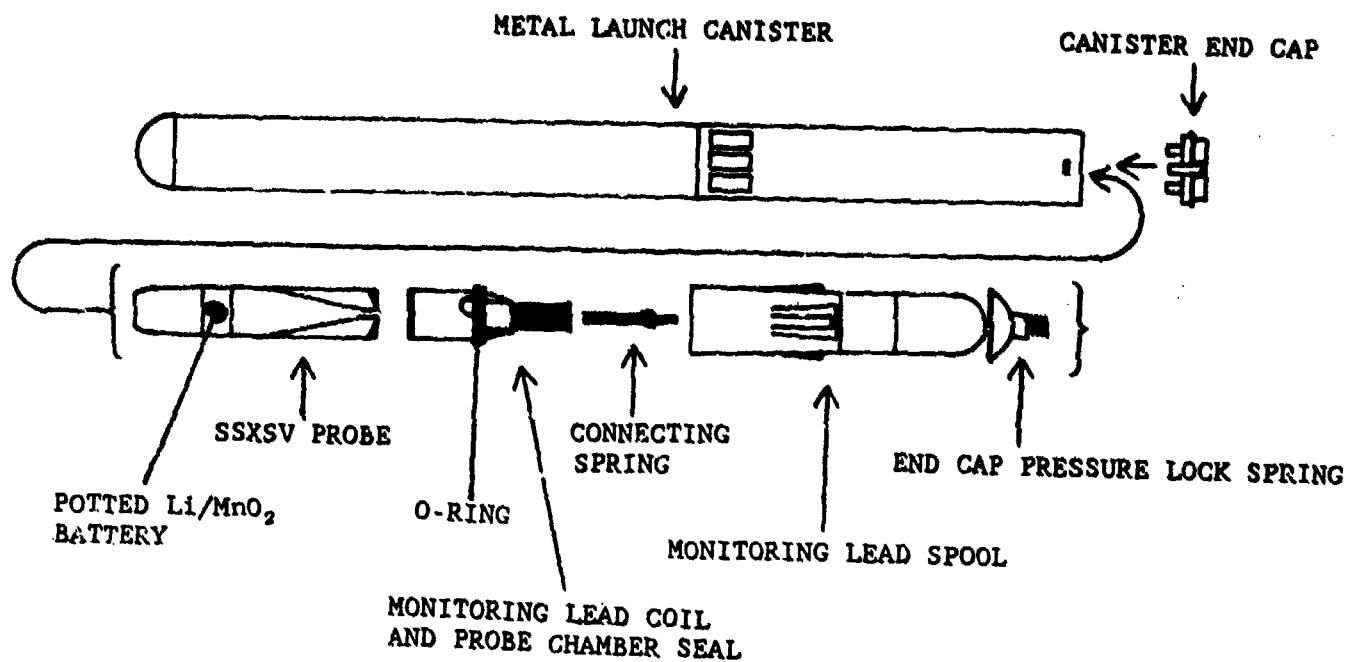
FIGURE 1. SSXSV PROBE/CANISTER CONFIGURATION

The SSXSV probe pictured in Figure 1 consists of a small probe and a monitoring lead spool (for transmitting sound data to the submarine), encased in a metal launch canister. The canister is 98cm in length and 7.5cm in diameter. The portion of the canister which contains the probe and battery is sealed, isolating the probe and battery from the outside atmosphere. The battery being used employs a lithium/manganese dioxide ( $\text{Li/MnO}_2$ ) couple, comprised of three 3-volt (V) cells. The single cells are Duracell DL<sub>3</sub>N cells. The anode, cathode, and total cell reactions are given by equations 1, 2, and 3, respectively. Two of the DL<sub>3</sub>N cells

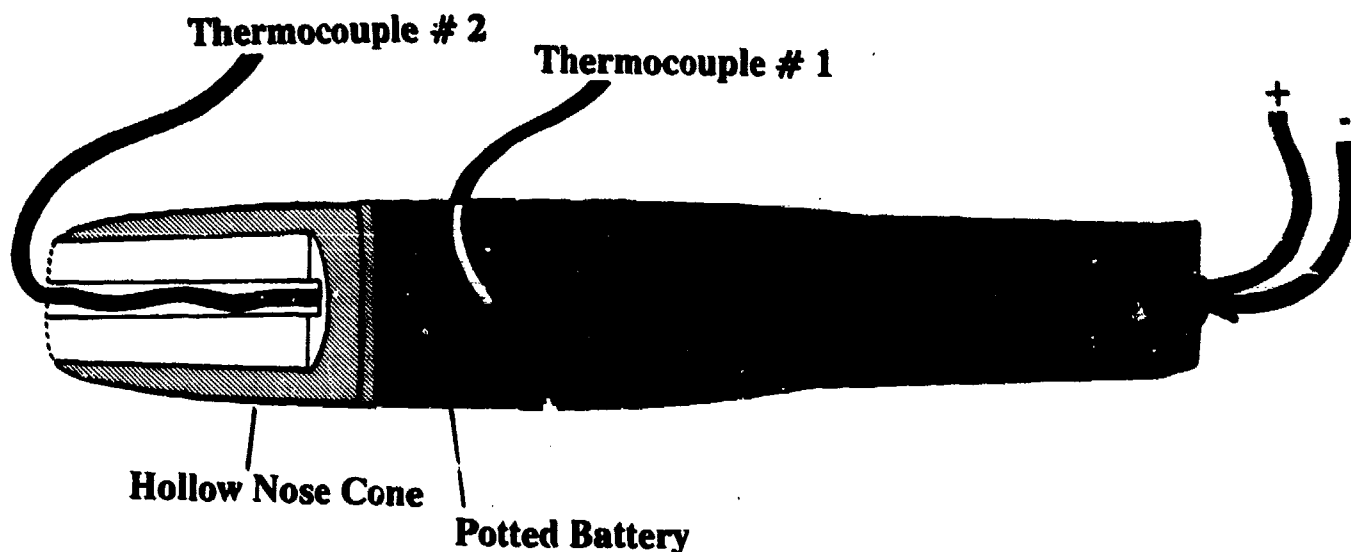
FIGURE 2. SSXSV PROBE THERMOCOUPLE PLACEMENT

Three batteries were shorted through less than .02Ω inside SSXSV probes. The voltage, current, and two thermocouples were monitored on each probe. For the first battery, a thermocouple was placed on the canister and a thermocouple was placed just inside the canister (where the voltage leads protruded through a plastic sealing cap). For the next two batteries tested, the placement of the thermocouples was changed. The probes were removed from the canisters and one thermocouple was placed just over the battery on the battery potting - the location of the battery was found using a magnet. The second thermocouple was placed in the nose hole of the probe. Figure 2 shows the placement of the thermocouples on the probe.

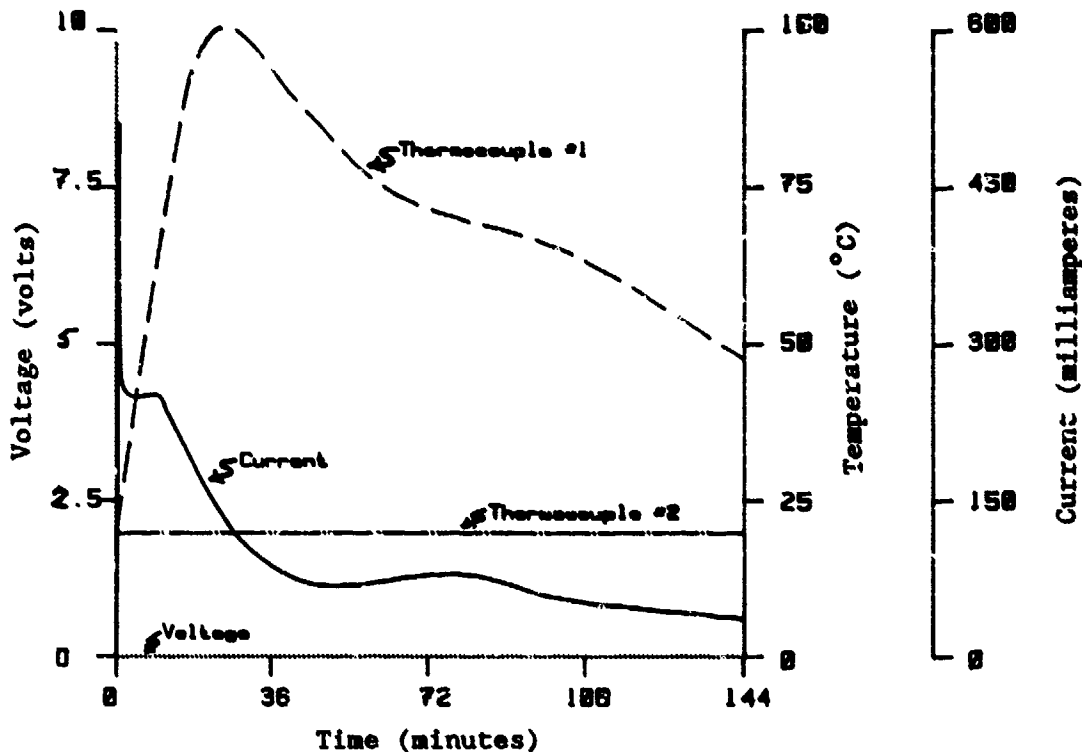
FIGURE 3. SHORT CIRCUIT OF AN SSXSV BATTERY NOT POTTED IN A PROBE

Six SSXSV batteries (one DL<sub>3</sub>N cell in series with one PX28L battery) were shorted. In less than five minutes voltage readings fell from 9.8 volt to 0 volt. Figure 3 is a representative graph of the short circuit tests. Note that within 30 minutes the temperature measured on the PX28L battery rose to a peak. On the average the peak temperature was 92°C. This temperature fell to ambient over a time period of about eight hours. The temperature measured on the single DL<sub>3</sub>N cell, however, remained ambient throughout the test. The SSXSV battery did not explode, vent, leak electrolyte, or show any signs of disfiguration due to shorting.

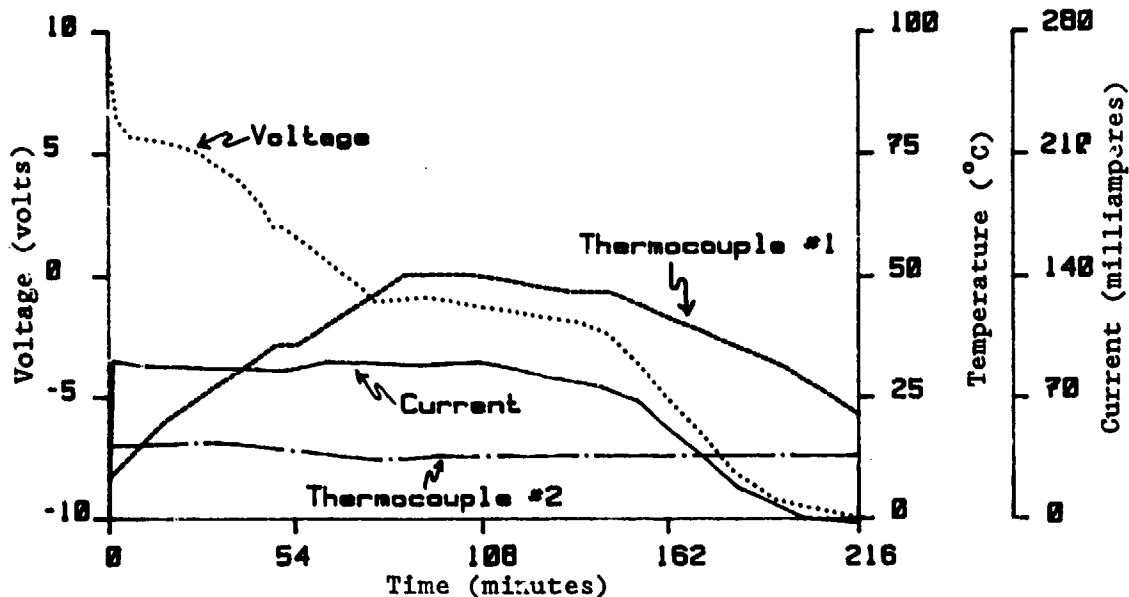
FIGURE 4. CONSTANT CURRENT DISCHARGE AND REVERSAL OF AN SSXSV BATTERY NOT POTTED IN A PROBE

Six SSXSV batteries were discharged at a constant current and forced into voltage reversal with a power supply. The batteries were discharged at the 80mA rate to 0 volt and then additionally driven 150 percent into voltage reversal at the same current. The voltage continued to drop and by the end of the test reached approximately -10V. During the first 75 minutes of the test, the voltage dropped markedly (on the order of 10V) and then leveled off for 65 minutes. During the last portion of the test, the voltage again dropped. During this period the current also dropped (Figure 4). The average maximum temperature recorded on a forced overdischarge was 57°C. This maximum temperature was again recorded on the PX28L and the DL<sub>3</sub>N cell can temperature remained ambient. Like the batteries that were shorted, the batteries discharged into reversal did not explode, vent, leak electrolyte, or show any signs of disfiguration.

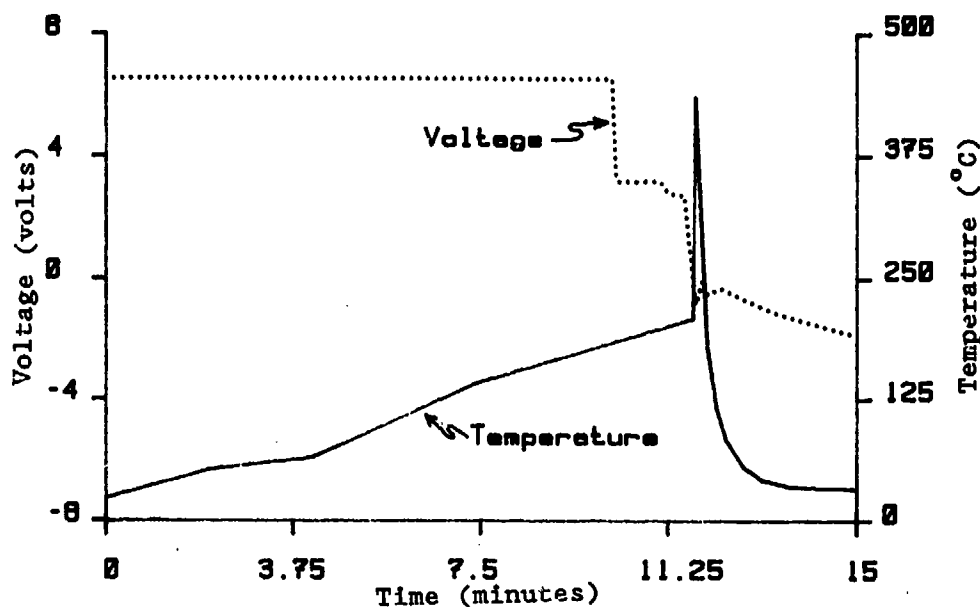
FIGURE 5. RESULTS OF HEATING A PX28L BATTERY

Two PX28L batteries were heated; at temperatures above 200°C, the negative ends of the batteries vented and severed the heat tape. A few minutes prior to the batteries venting, the open circuit voltage (OCV) faltered and began to drop. Figure 5 is a representative graph of a high temperature test conducted on a PX28L battery. The maximum temperatures recorded were 350°C and 435°C at the moment when failure occurred. Each cell in the battery failed at approximately the same time (differing by less than five seconds). The first cell failure occurred when the temperature maximum occurred. There was a small amount of burning (flames lasting less than ten seconds) associated with the failure of each battery.

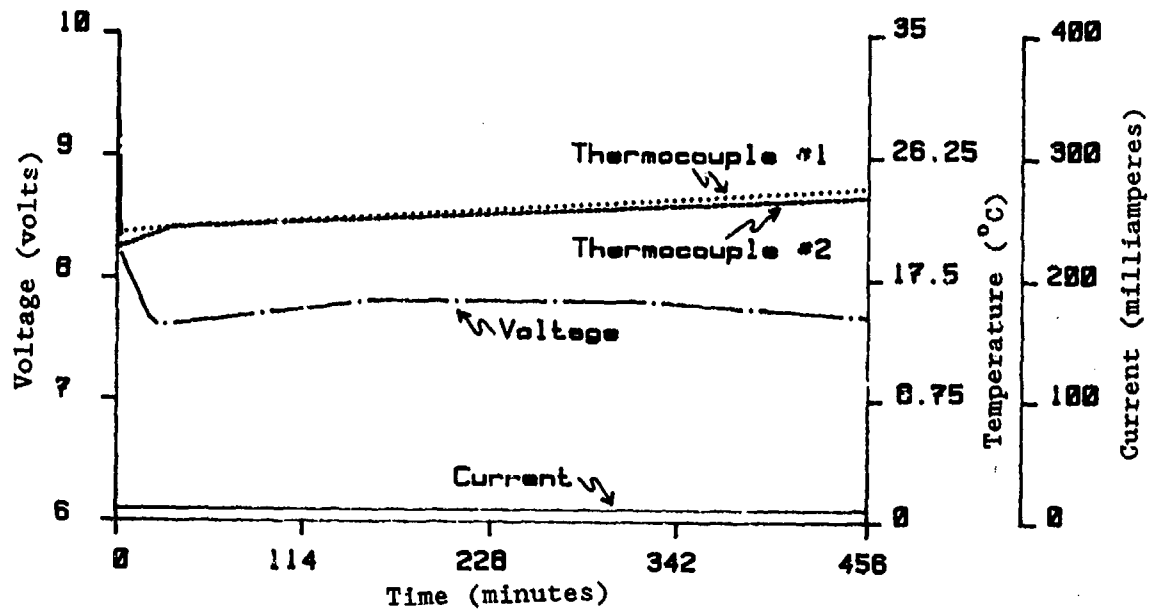
FIGURE 6. 10mA DISCHARGE OF AN SSXSV BATTERY (NOT POTTED IN A PROBE) TO 50% OF THE ORIGINAL CAPACITY

Three SSXSV batteries were discharged at the 10mA rate and then charged at the 100mA rate. The first battery was discharged 50 percent. During the discharge, the temperature on the PX28L and the DL<sub>3</sub>N rose less than 5°C. During charging, the temperature on the DL<sub>3</sub>N remained ambient but the temperature of the PX28L rose to 84°C. However, there was no explosion, venting, leakage of the electrolyte, or any signs of disfiguration. Figures 6 and 7 show the discharge and charging curves for this battery. The next battery was discharged at the 10mA rate to remove 80 percent of the capacity. The discharge took place over a period of two days and the temperatures measured on the PX28L and the DL<sub>3</sub>N remained ambient. Figures 8 and 9 show the discharge curves for day one and two, respectively. Following discharge, the battery was charged at a current of 100mA. Thirty minutes into the charge, the battery vented. Small flames were observed which lasted about five seconds. From the beginning of the test, the temperature on the PX28L increased but the DL<sub>3</sub>N temperature remained at ambient. It was the DL<sub>3</sub>N that had ruptured even though its temperature was the one that remained at ambient. The temperature on the PX28L peaked at 108°C. The flames associated with the rupture burned in the area where the thermocouple was located on the single cell. For this reason it was deduced that thermocouple no. 2 was not working properly, which gave false ambient readings on the DL<sub>3</sub>N cell. The current for this test started at 100mA as planned but unexpectedly increased to 220mA at the time of and just before the rupture. Figure 10 is a summary of this data. Another SSXSV battery was tested in the same manner to try and reproduce the results obtained in the previous charging. The results, however, were not the same; during charging the

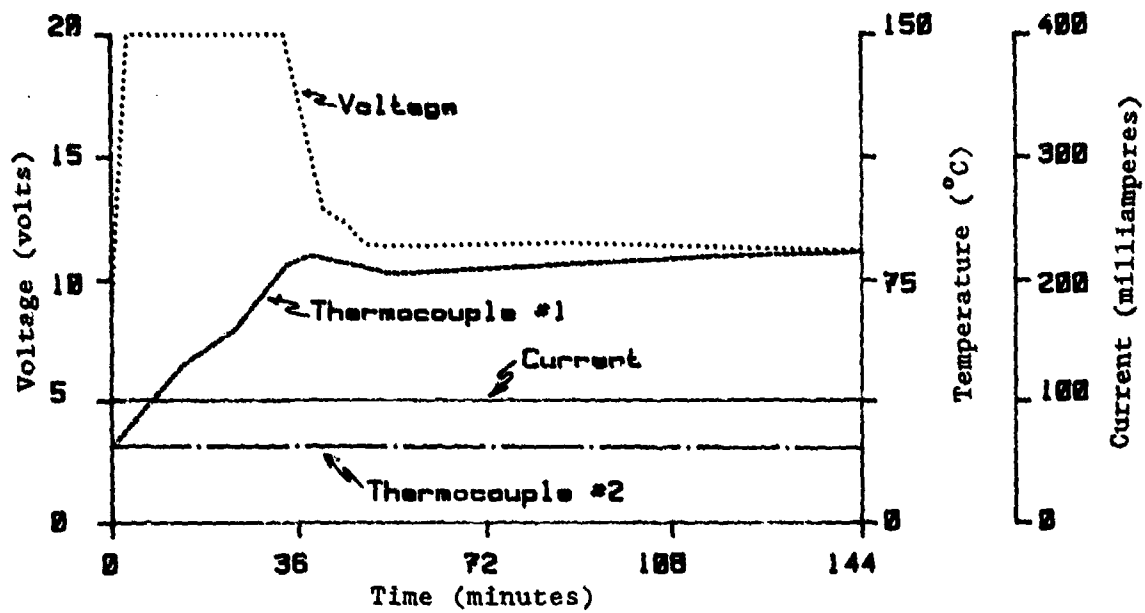
FIGURE 11. NORMAL CHARGING DATA OF AN 80% PREVIOUSLY DISCHARGED SSXSV BATTERY NOT POTTED IN A PROBE

temperature of the PX28L rose to 82°C after 30 minutes and remained elevated. The temperature on the DL<sub>3</sub>N remained at ambient. After 30 minutes, the voltage dropped and the current remained relatively constant throughout the test. Figure 11 summarizes the charging data of this SSXSV battery.

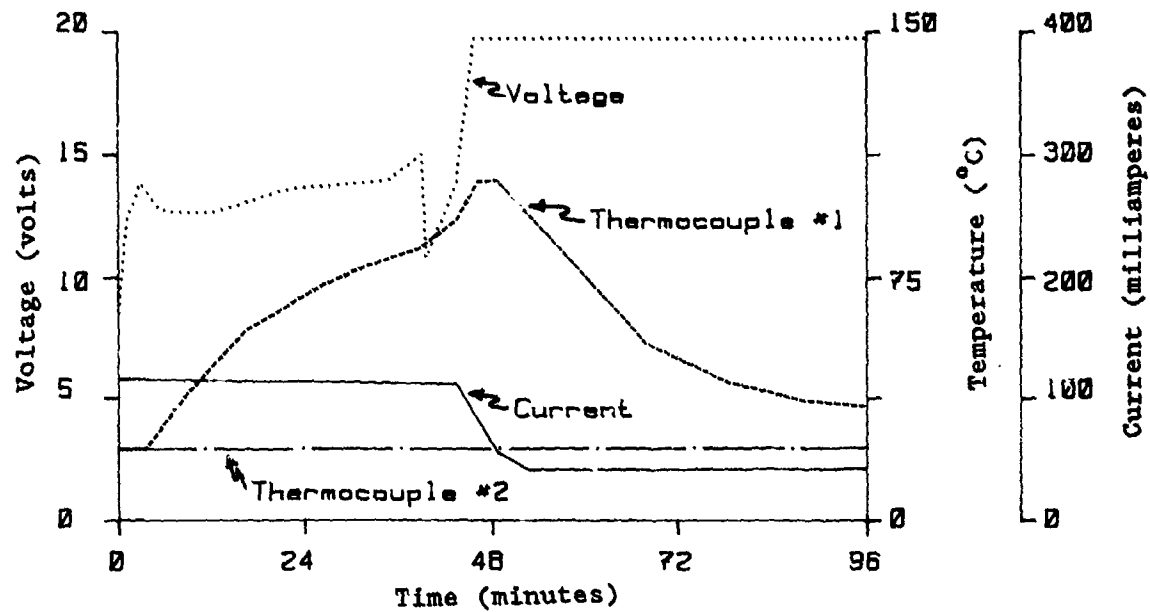
FIGURE 12. DATA FOR THE FIRST 96 MINUTES OF CHARGING A FRESH SSXSV BATTERY NOT POTTED IN A PROBE

One SSXSV battery was charged at the 100mA rate for four hours. All the pertinent data was recorded within the first 90 minutes of the test, and after 96 minutes the graphed data showed no change. Figure 12 shows the first 96 minutes of testing for this battery. The charging current was approximately 100mA initially. Forty minutes into the test, the power supply voltage automatically increased in response to a reduction in current caused by an apparent increase in battery impedance. The voltage reached the upper limit of the power supply at 20V. During this time, the temperature on the PX28L had peaked at 105°C. When the current had dropped to about 40mA the temperature began dropping. The DL<sub>3</sub>N temperature remained ambient and there was no explosion, venting, or leakage of electrolyte. However, both the PX28L and the DL<sub>3</sub>N showed signs of swelling.

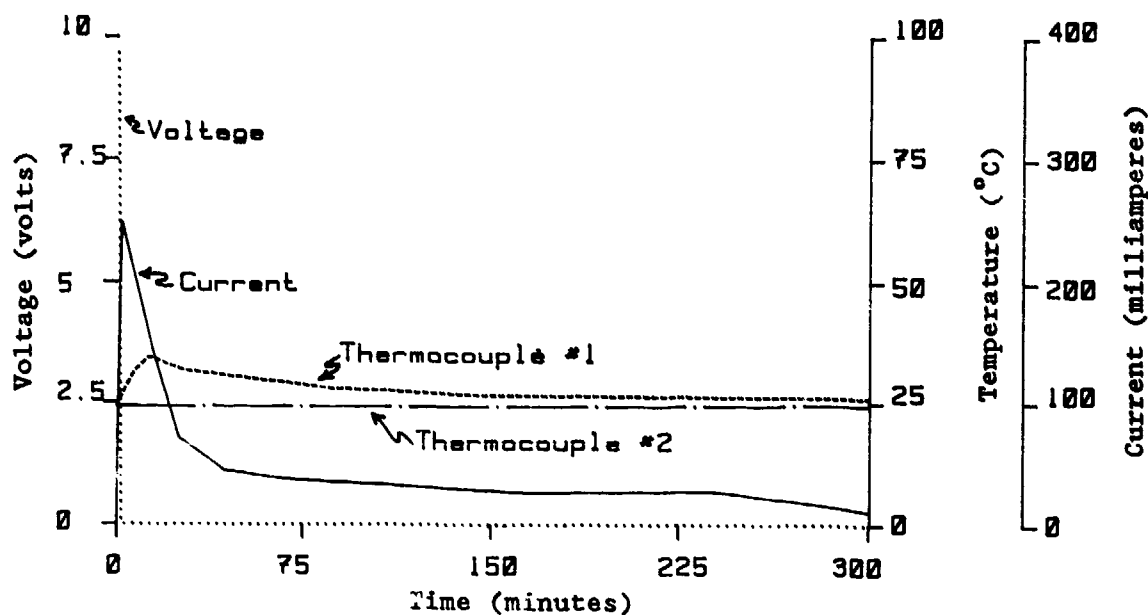
FIGURE 13. SHORT CIRCUIT DATA FOR AN SSXSV BATTERY POTTED IN A PROBE

Three SSXSV batteries, potted in three SSXSV probes, were shorted. Probe 1 (serial no. 13973) was shorted inside the SSXSV canister. The discharge curve

resembled the discharge curves of the SSXSV batteries previously shorted. The temperatures monitored, however, were recorded as ambient. The thermocouples had been placed on the exterior of the canister; for the next two short circuit tests, the batteries (in probes) were tested outside the canister. Temperatures of the battery potting were monitored on the next two probes. The discharge curves for probe 2 (serial no. 13974) and probe 3 (serial no. 13975) were similar to the discharge curve for probe 1 in all respects except temperature. The average maximum temperature recorded on the potting of the two probes was 35°C, about 10°C above ambient. Figure 13 is a representative graph of shorting SSXSV batteries potted in probes. During these three tests, there were no ventings, explosions, leakage of electrolyte, or noticeable disfigurements associated with the probes. Dissection of the probes also disclosed that the batteries had not vented, exploded, leaked electrolyte, or become disfigured.

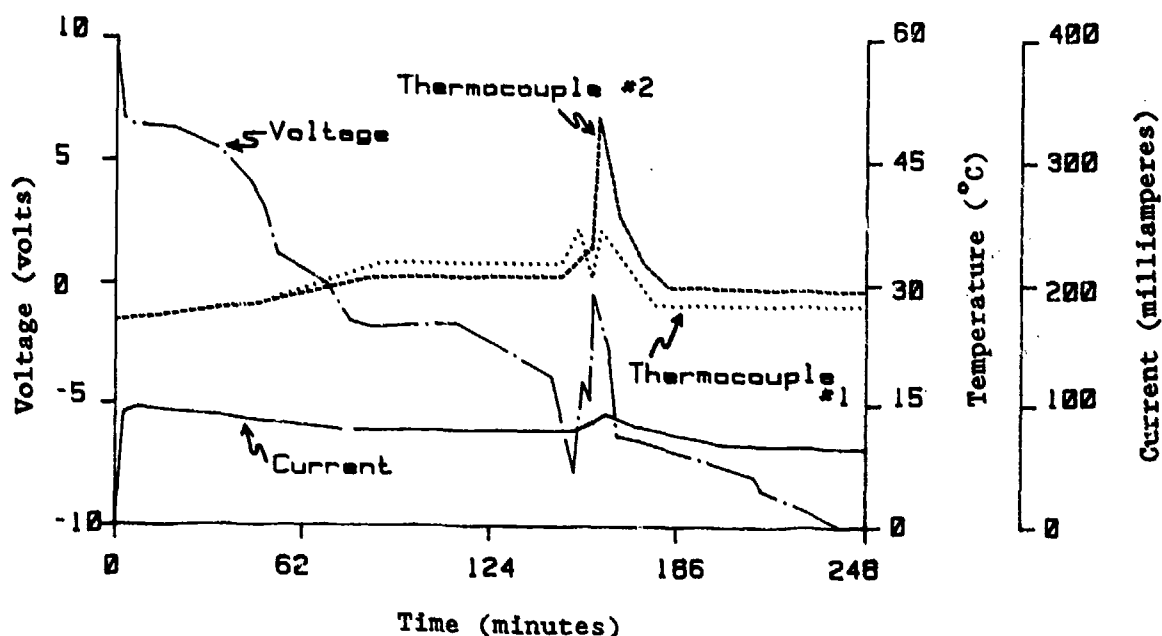
FIGURE 14. FORCED OVERDISCHARGE OF AN SSXSV BATTERY (POTTED IN A PROBE) AT THE C/2 RATE

Probe 4 (serial no. 13976), the first of four probes discharged into voltage reversal, had a crack in the battery potting prior to testing. The OCV of the battery was measured as 9.82V. Other OCV's for previous batteries tested were between 9V and 10V, so it was decided to proceed with the testing of this probe battery. No cause for the cracked potting was evident. The battery followed a normal discharge, reaching 0 volt, and then went into voltage reversal. After 2.5 hours of forced overdischarging, there was a venting (indicated by a "pop") accompanied by the tail piece cracking almost its entire length around the area where the potting was previously cracked. Three minutes later another venting occurred (also indicated by a "pop"). When the ventings occurred there was a noticeable smell, similar to the odor of ether. This probe was dissected. From

the arrangement of the cell, the battery, and the position of the crack it was not possible to say if thermal expansions, venting, or internal heat from either the PX28L or the DL<sub>3</sub>N caused the cracking. Testing performed on probe 5 (serial no. 13977) was similar to that of probe 4. The results were the same. About 2.5 hours into voltage reversal a venting occurred. The highest temperature seen for either probe was 51°C at the time of venting. Dissection of probe 5 revealed that thermal expansions in the DL<sub>3</sub>N and the proximity of this cell to the edge of the potting was the most probable cause of the cracking. Figure 14 is a representative graph for discharging an SSXSV battery (potted in a probe) into voltage reversal.

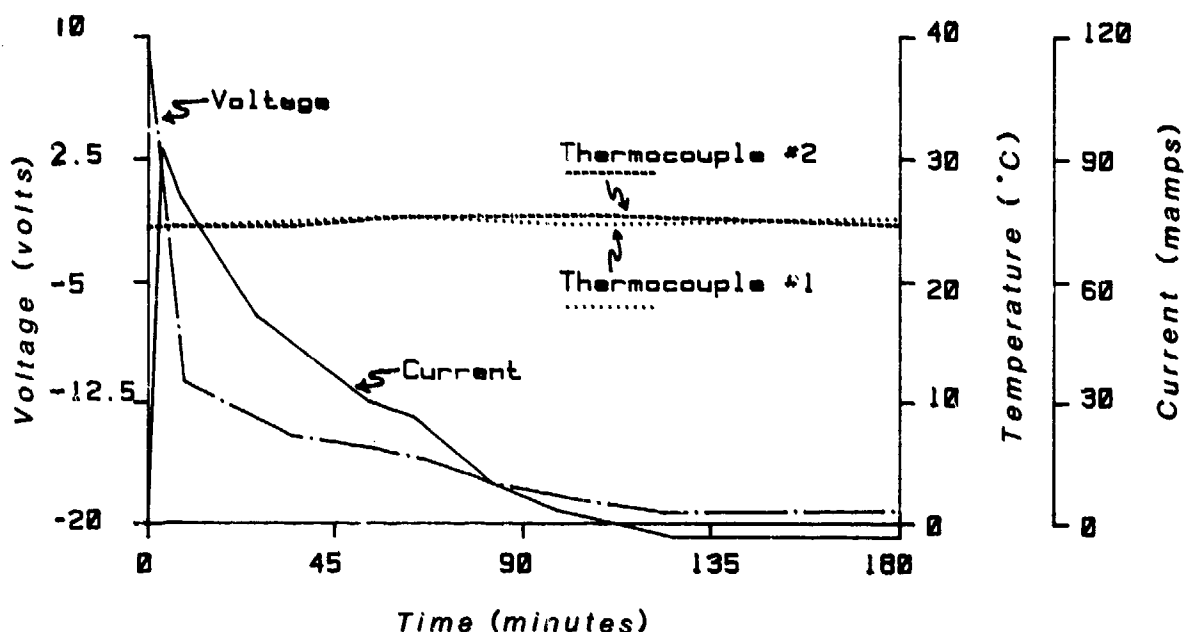
FIGURE 15. RESULTS OF FORCE OVERDISCHARGING AN SSXSV BATTERY (POTTED IN PROBE 7) AT THE C/2 RATE

Probe 6 (serial no. 13978) and probe 7 (serial no. 13979) were discharged into voltage reversal within the SSXSV canisters. The canister of probe 6 was pressure tested by filling it with oxygen ( $O_2$ ) to 8 psi. After confirming that the canister was indeed a sealed environment, it was fitted with a gas collection vessel. About 2.5 hours into the discharge (the battery was into reversal at this time) venting occurred with a flame exiting the tube around the o-ring seal. However, this test was judged to be invalid as a test of canister durability. Apparently, a greater amount of  $O_2$  than normal was trapped inside the canister, causing this reaction. If this were true, the gas sample collected from this canister would be expected to contain more  $O_2$  than a sample collected from a canister in which the battery vented under normal conditions. Indeed, mass spectrometric analysis of off-gas products, performed by the National Bureau of Standards (project no. 5533462), revealed that this was the case. Probe 7 was also tested in the same manner as probe 6, with the exception that  $O_2$  was not used to check canister sealing integrity. Probe 7 did not vent during discharge into voltage reversal at the 80mA rate, so 1 ampere (A) was driven through the battery by 100V which caused a mild venting. This allowed a gas sample to be collected. The off-gas products of probe 7 were also analyzed. From Figure 15 it can be

seen that the voltage and current monitored on probe 7 dropped very rapidly unlike other discharges into voltage reversal. The temperatures monitored on probes 6 and 7 were on the outside of the canister which explains their ambient readings throughout testing.
